## TECHNICAL SPECIFICATION FOR ASBESTOS REMEDIATION

**Ken-O-Sha Park Elementary**

1353 Van Auken Street, SE in in Grand Rapids, Michigan

*MicroAir Project No.:* **MA-114-25**

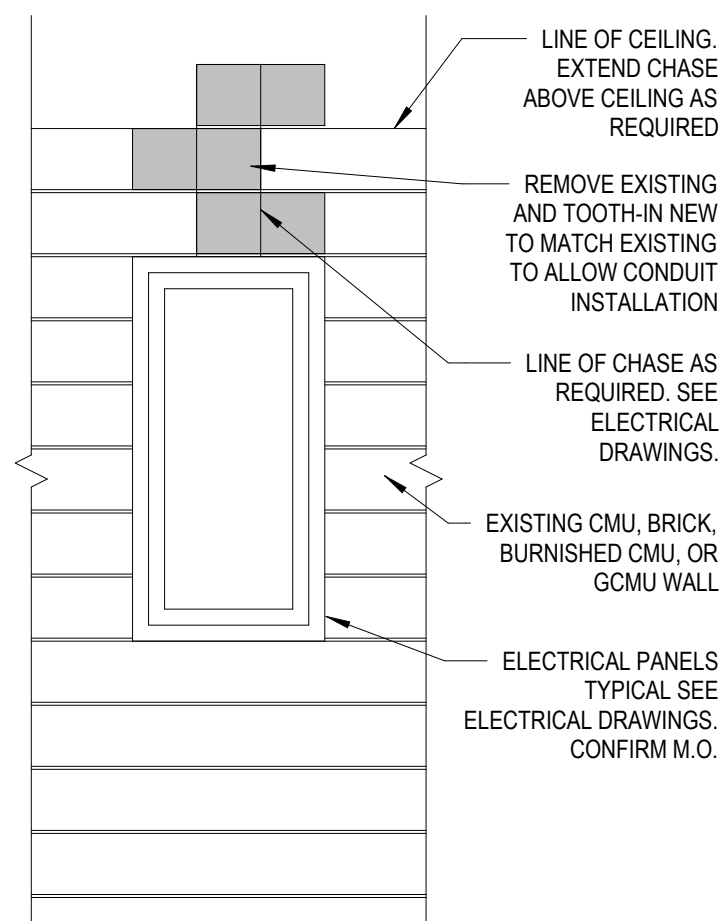
## TYPICAL ELECTRICAL DEVICE INSTALLATION IN EXISTING WALL

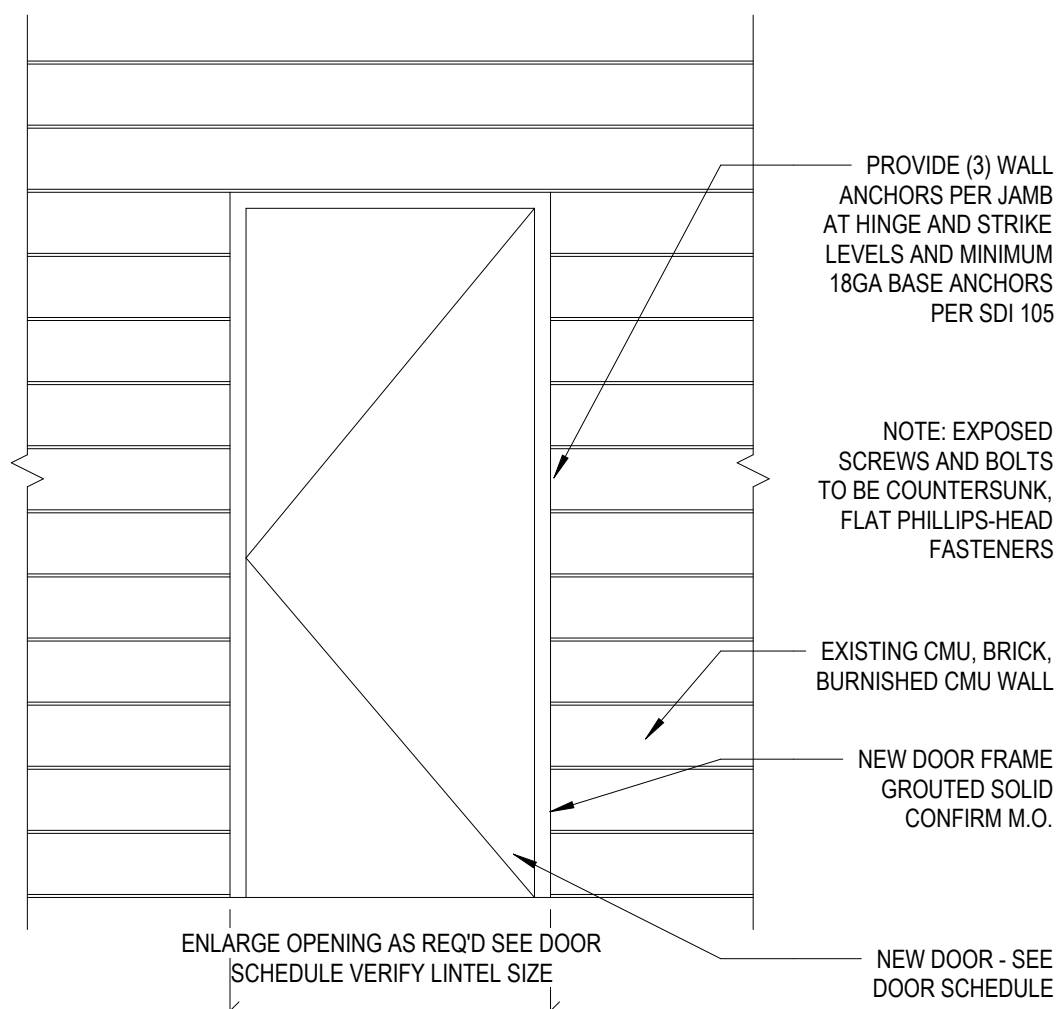
## TYPICAL DOOR INSTALLATION IN EXISTING MASONRY OPENING

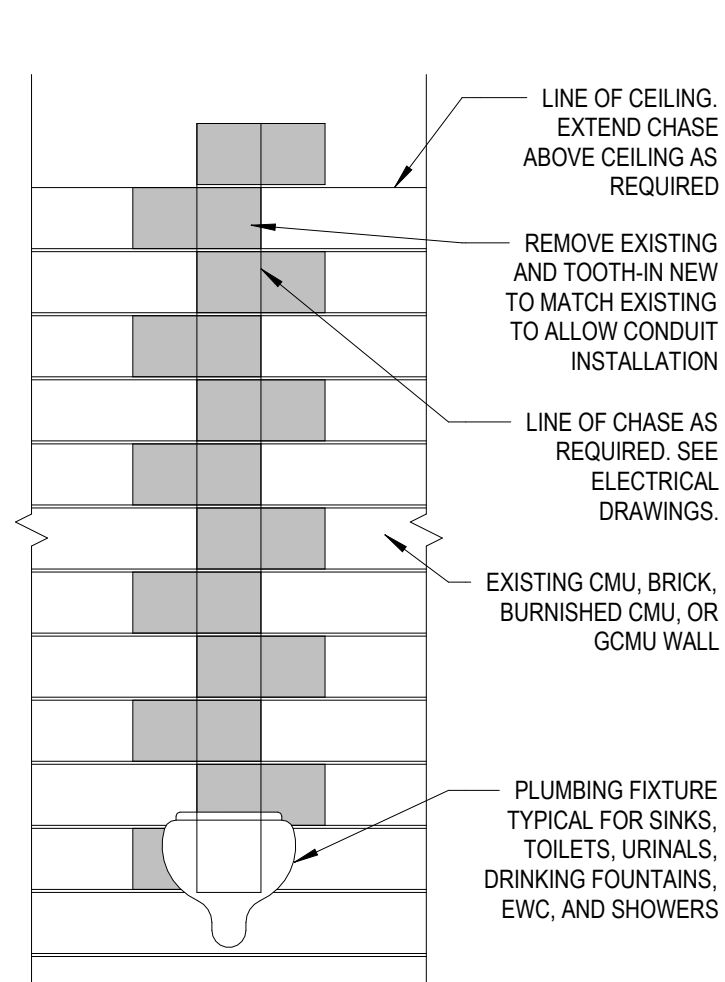
## TYPICAL PLUMBING FIXTURE INSTALLATION IN EXISTING WALL

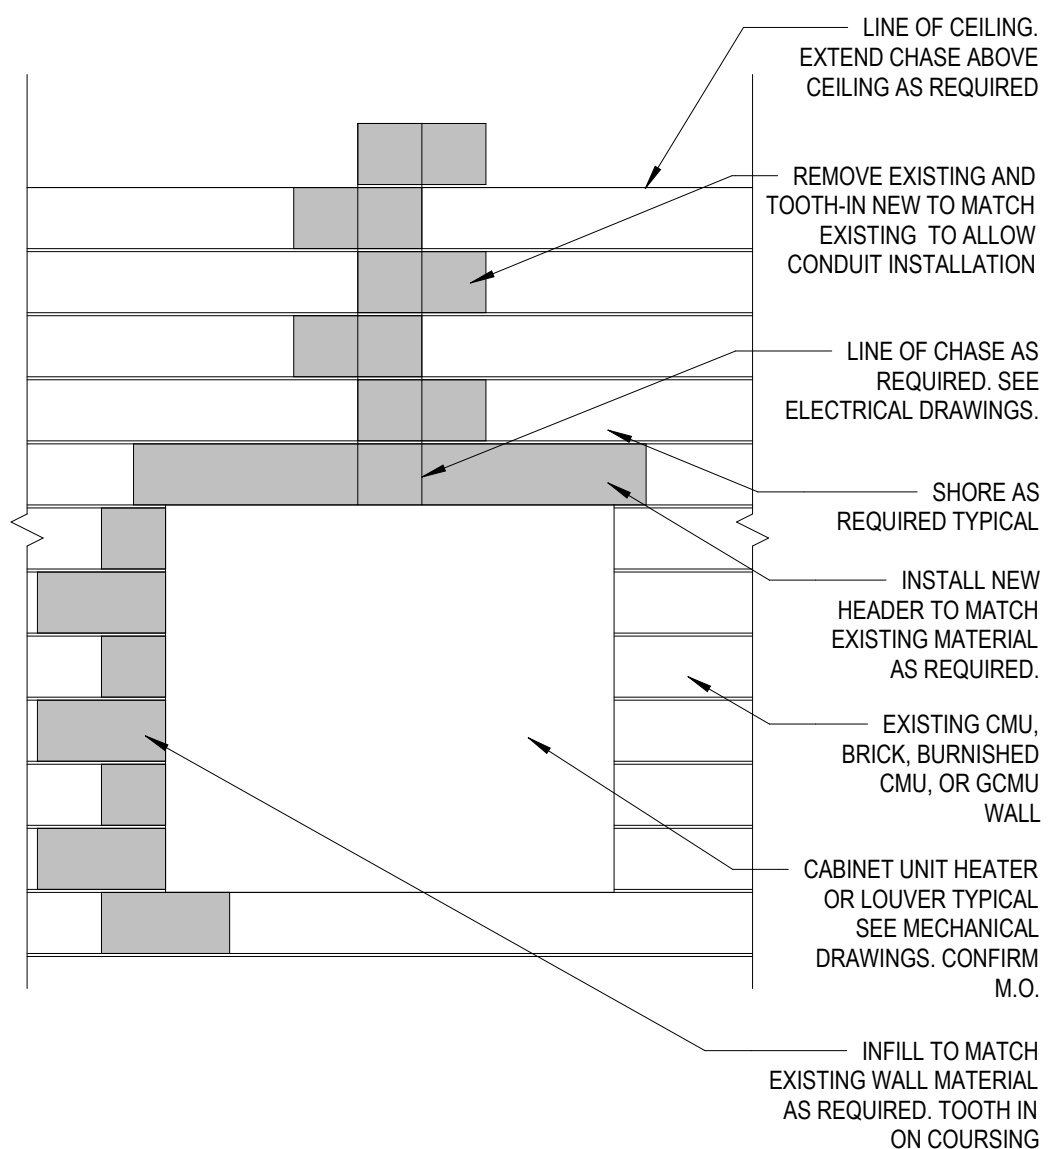
TYPICAL CABINET UNIT HEATER OR LARGE LOUVER INSTALLATION IN EXISTING WALL

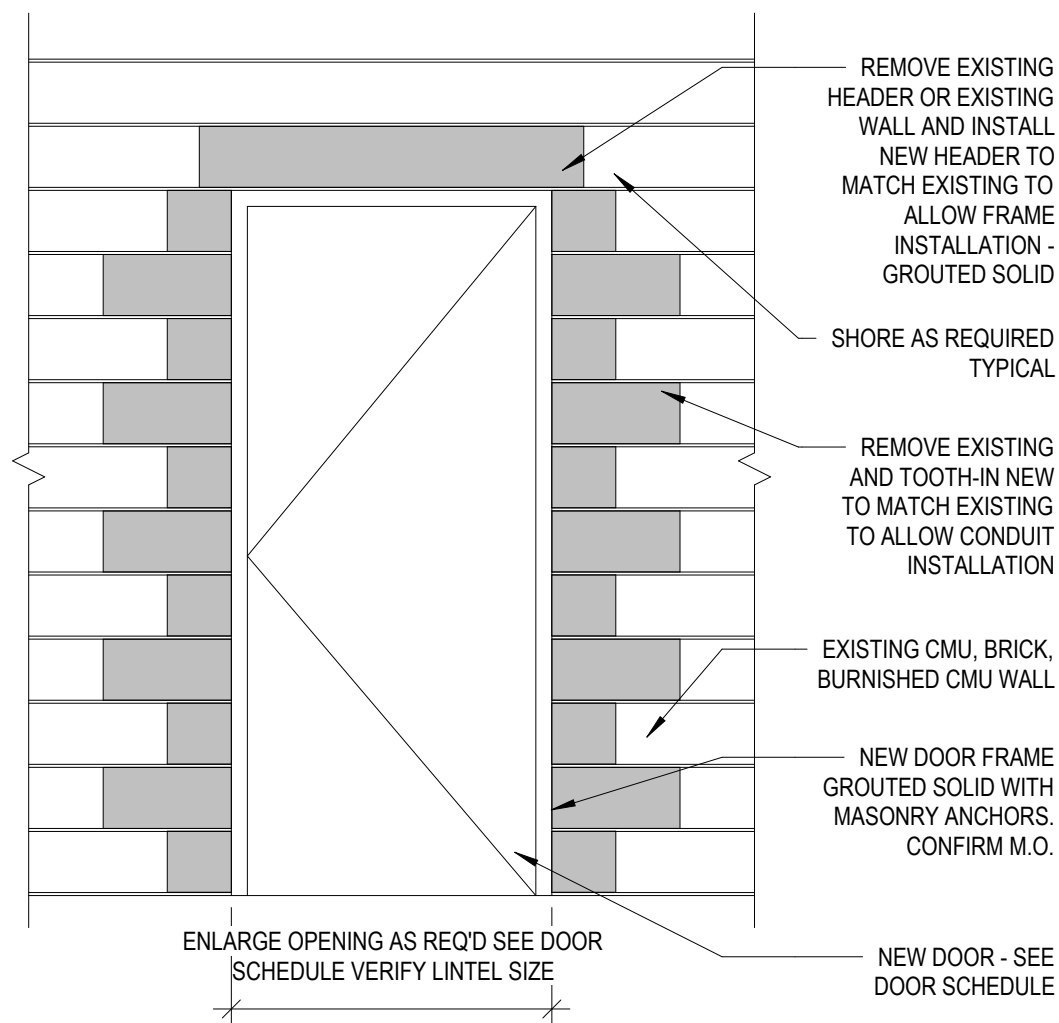
## TYPICAL DOOR INSTALLATION IN EXISTING MASONRY WALL

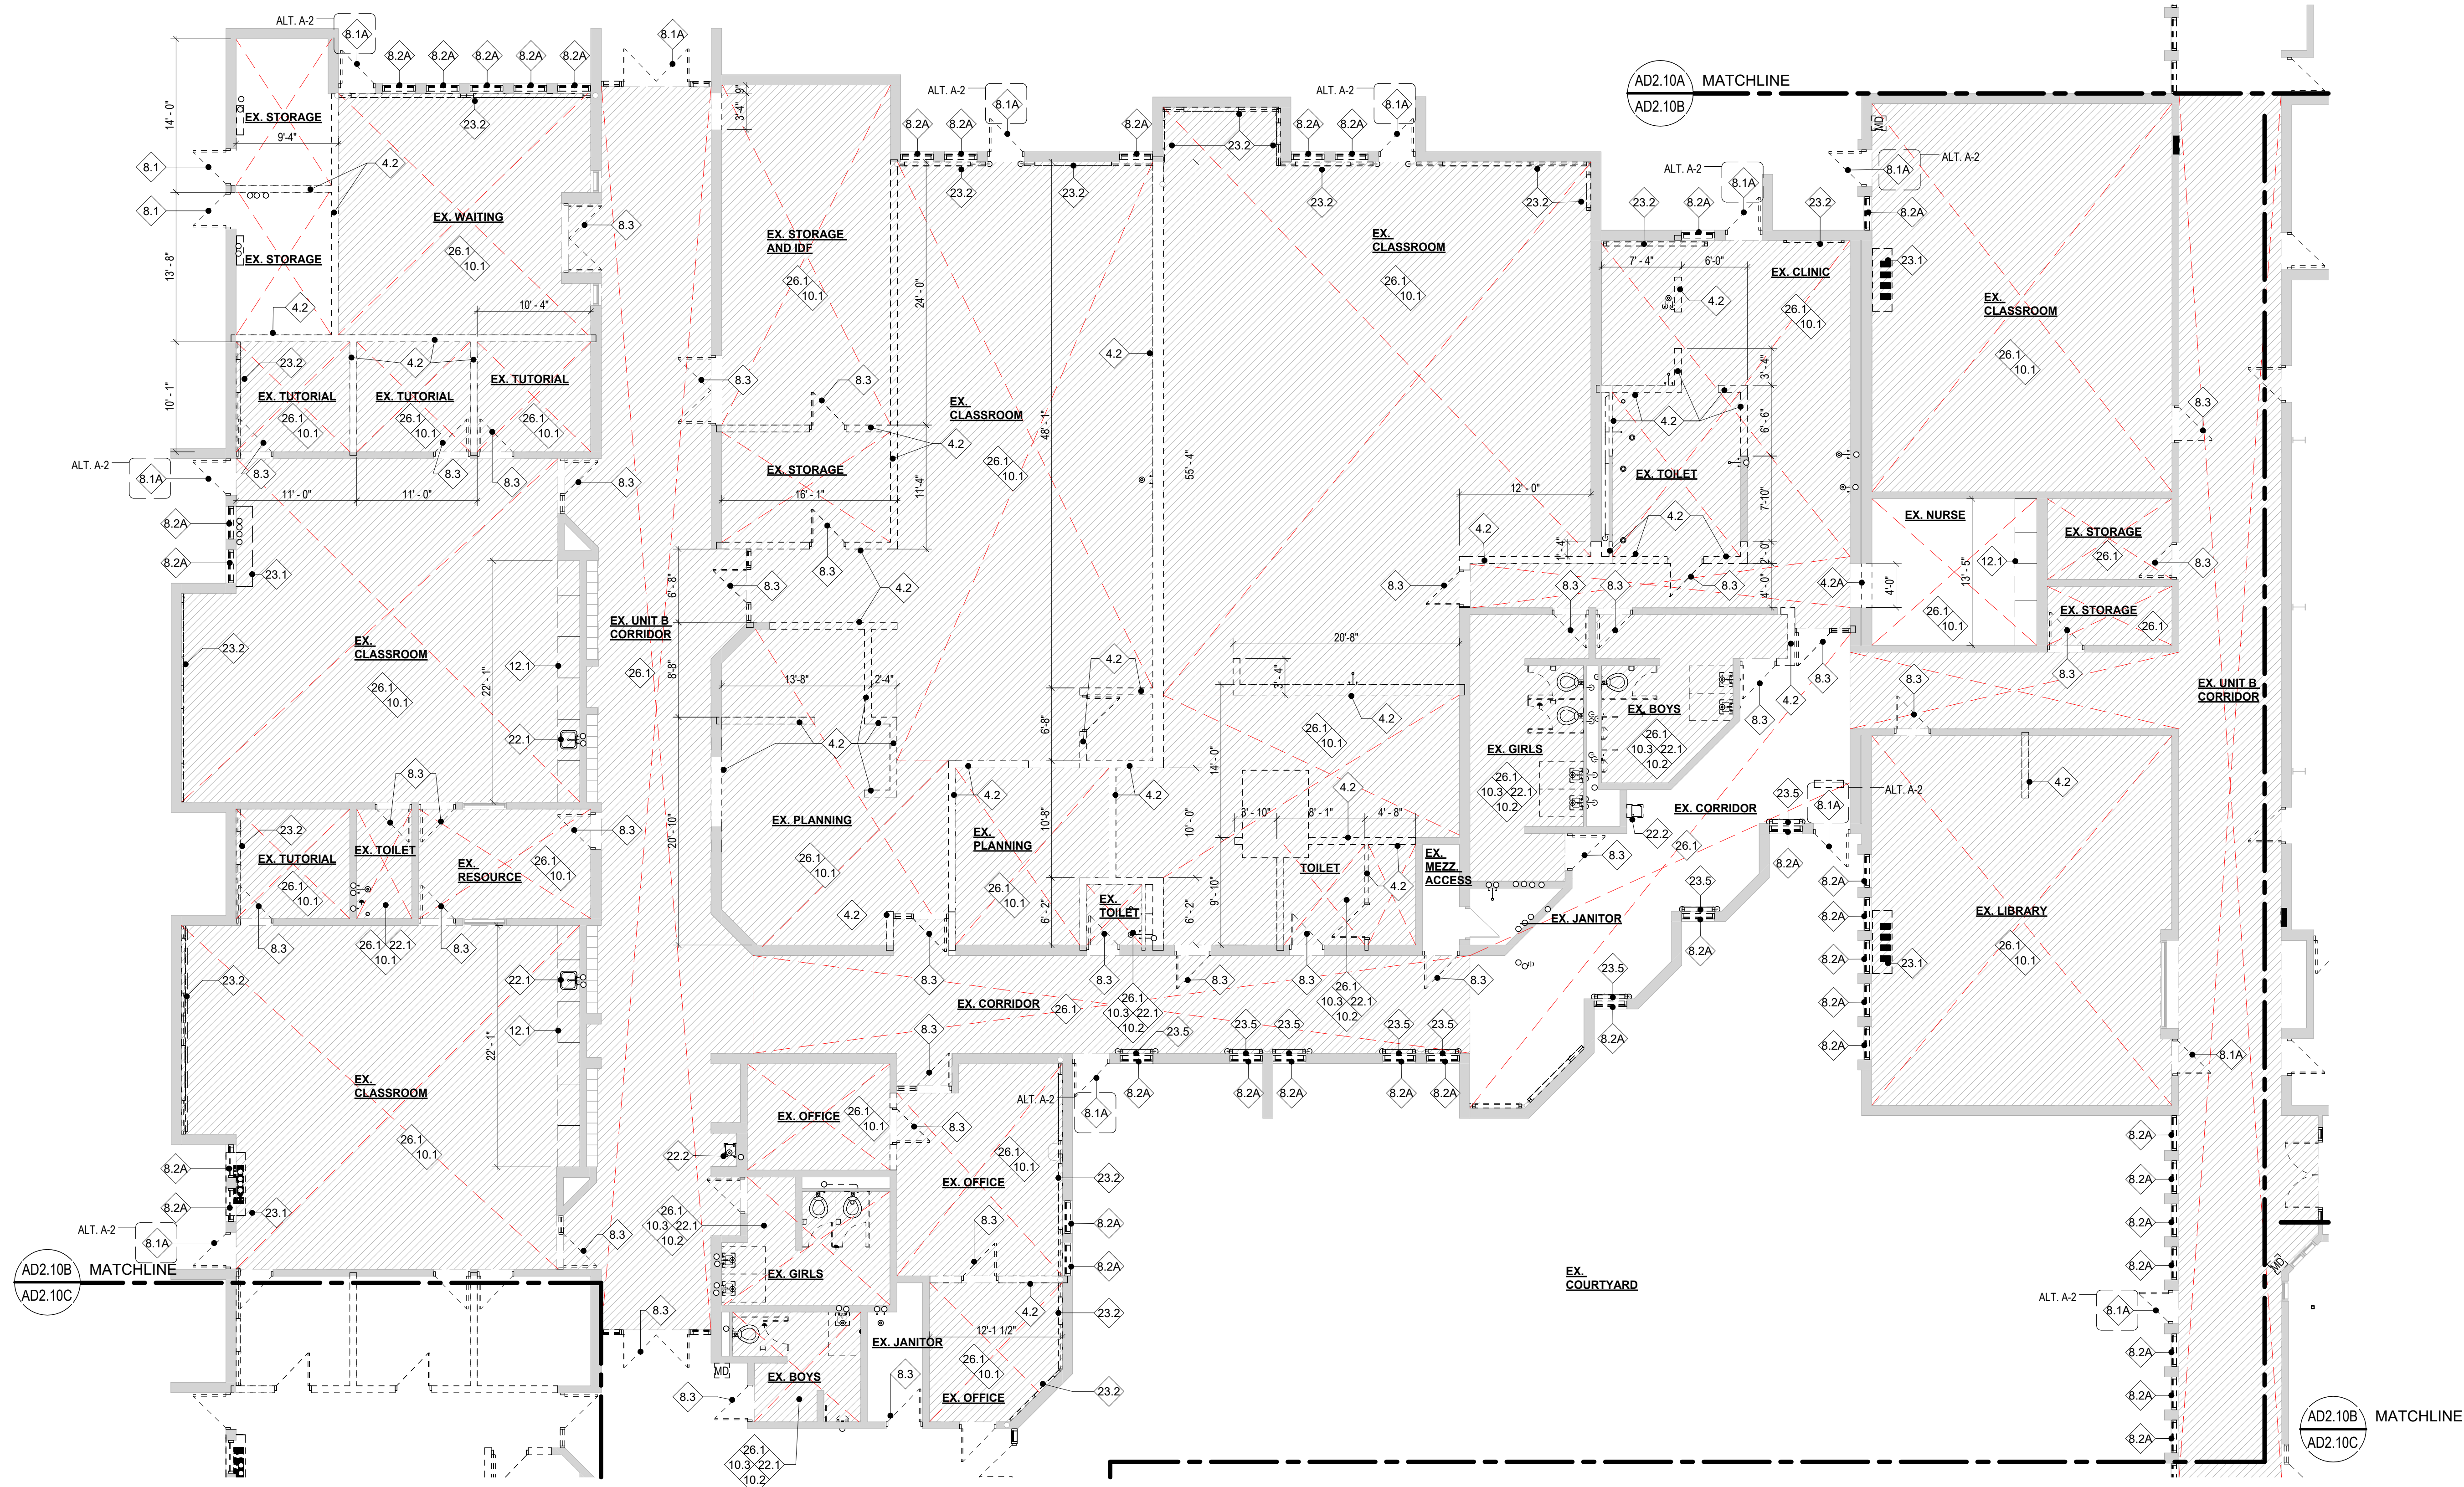
**UNIT B FIRST FLOOR DEMOLITION PLAN**  
SCALE: 1/8" = 1'-0"

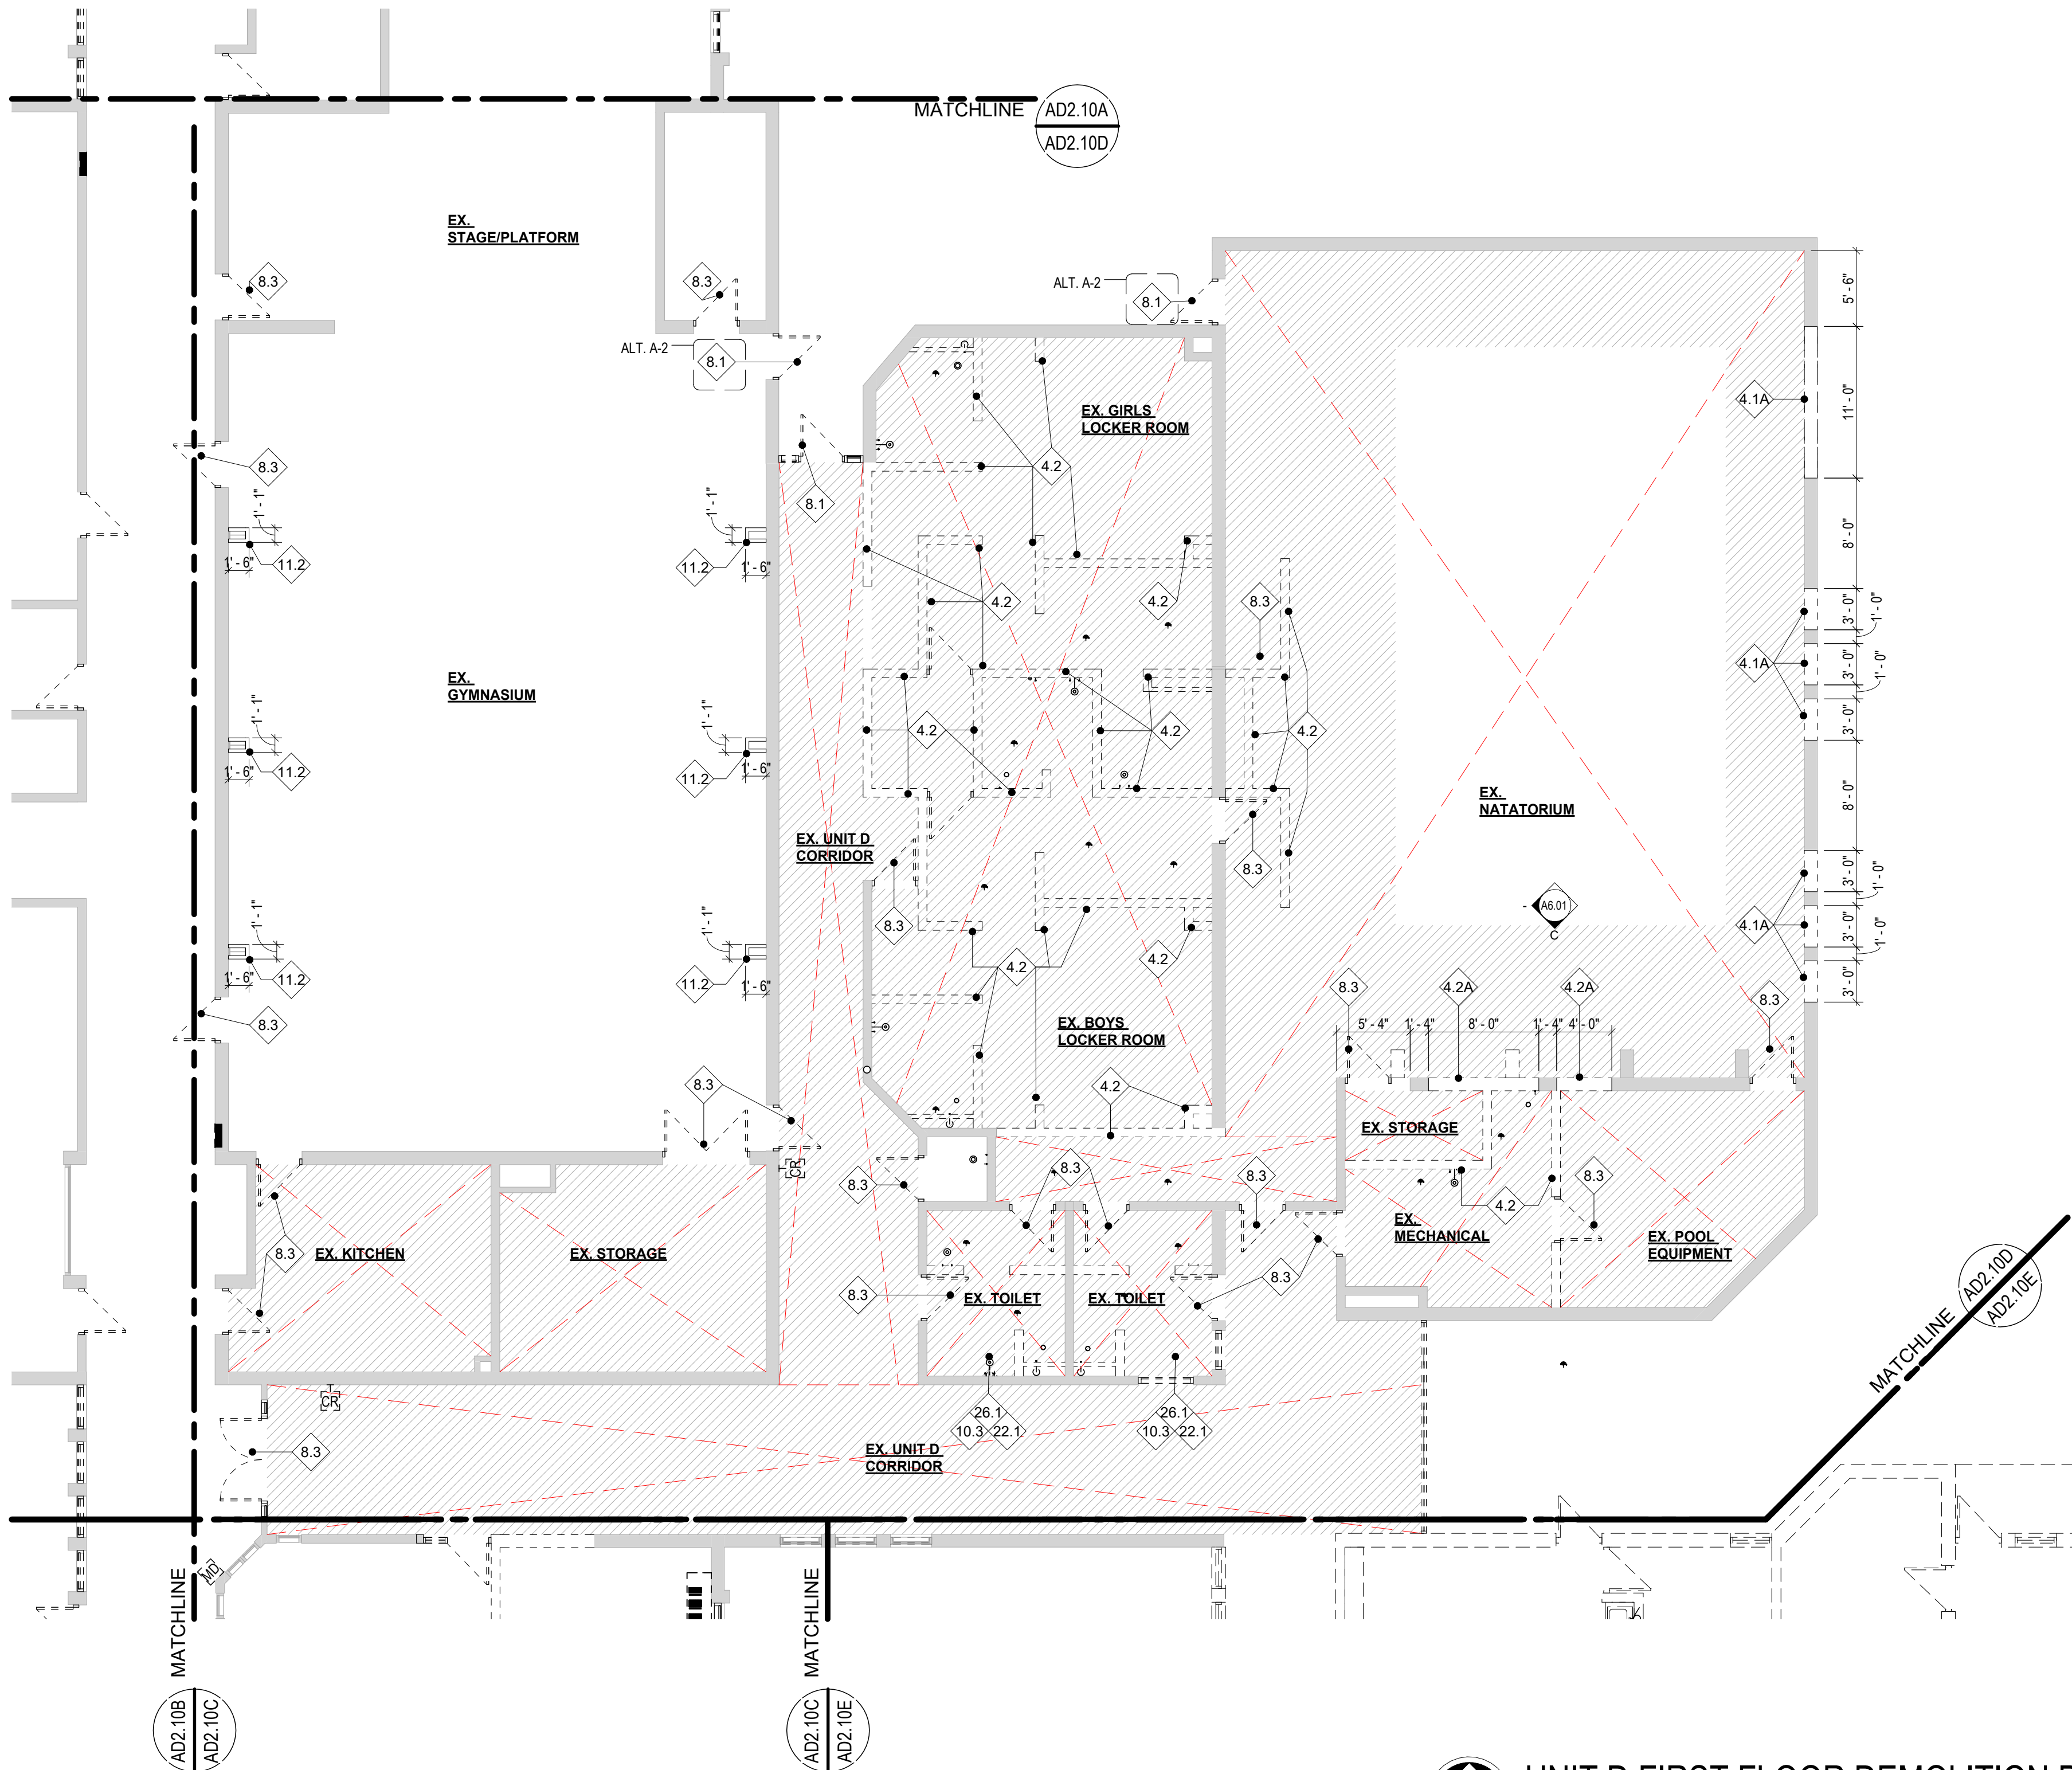
AD2.10D

UNIT D FIRST FLOOR DEMOLITION PLAN

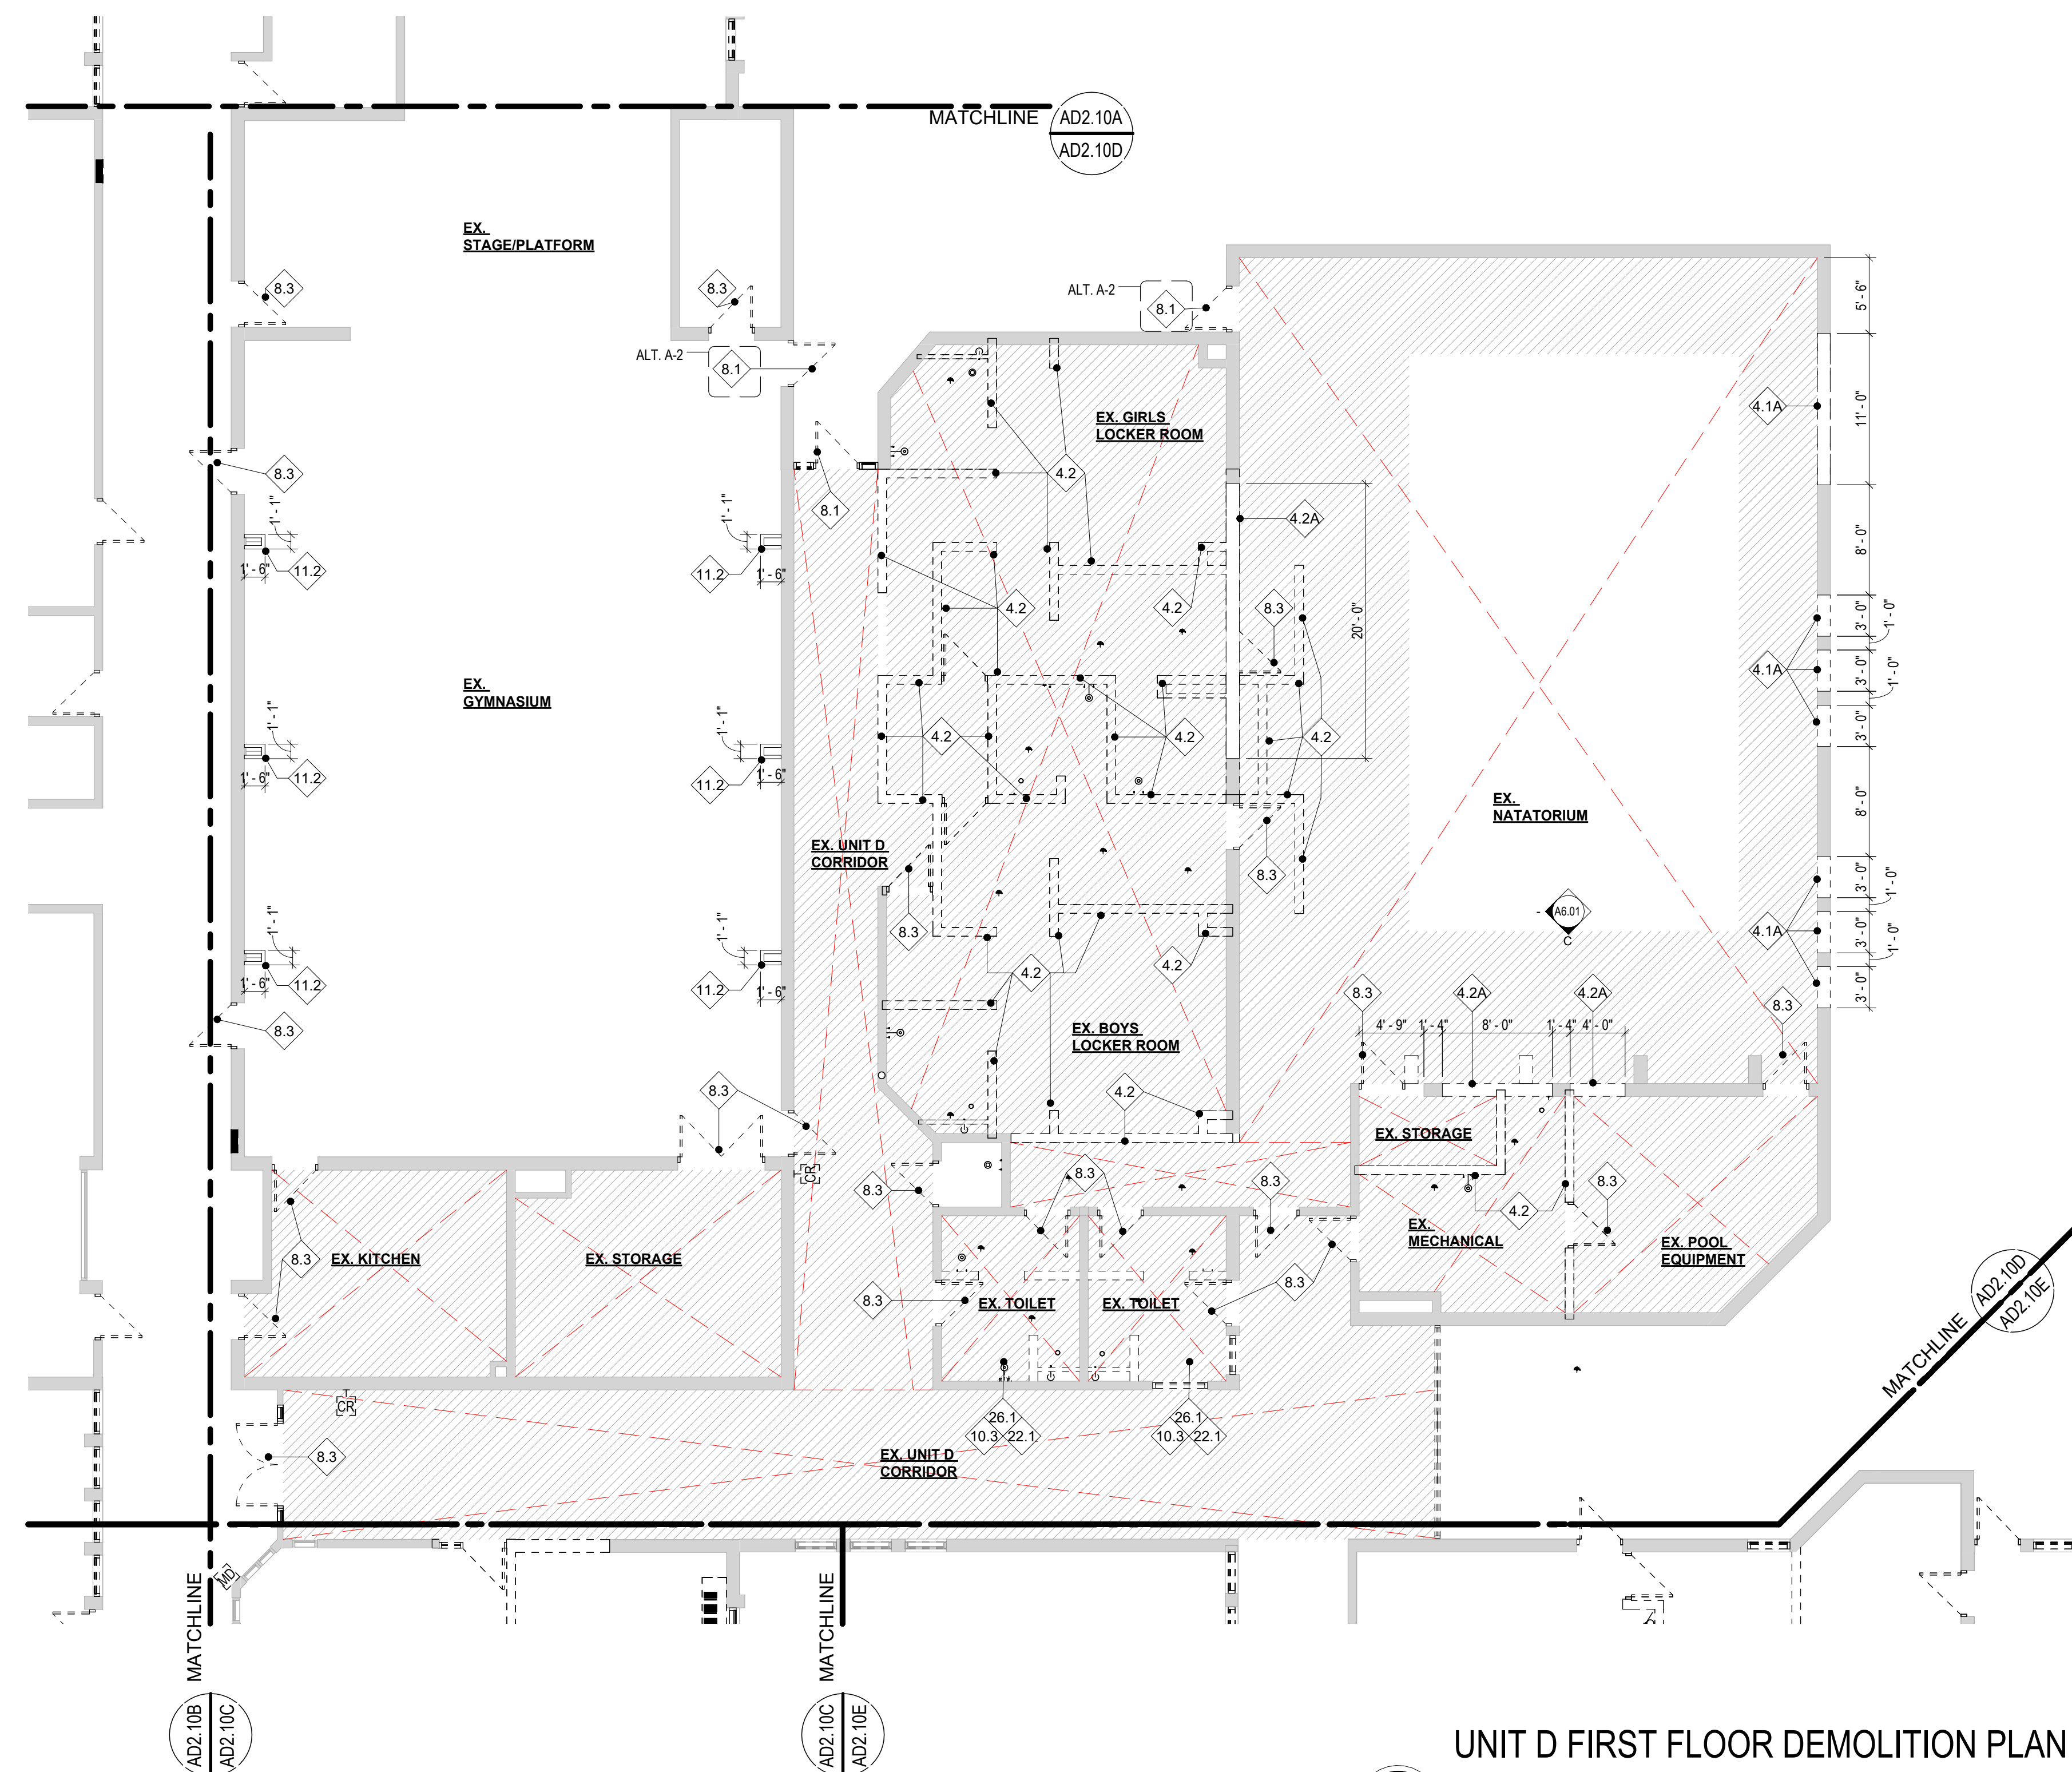
AD2.10D-A.1

UNIT D FIRST FLOOR DEMOLITION PLAN - ADD  
ALT.1

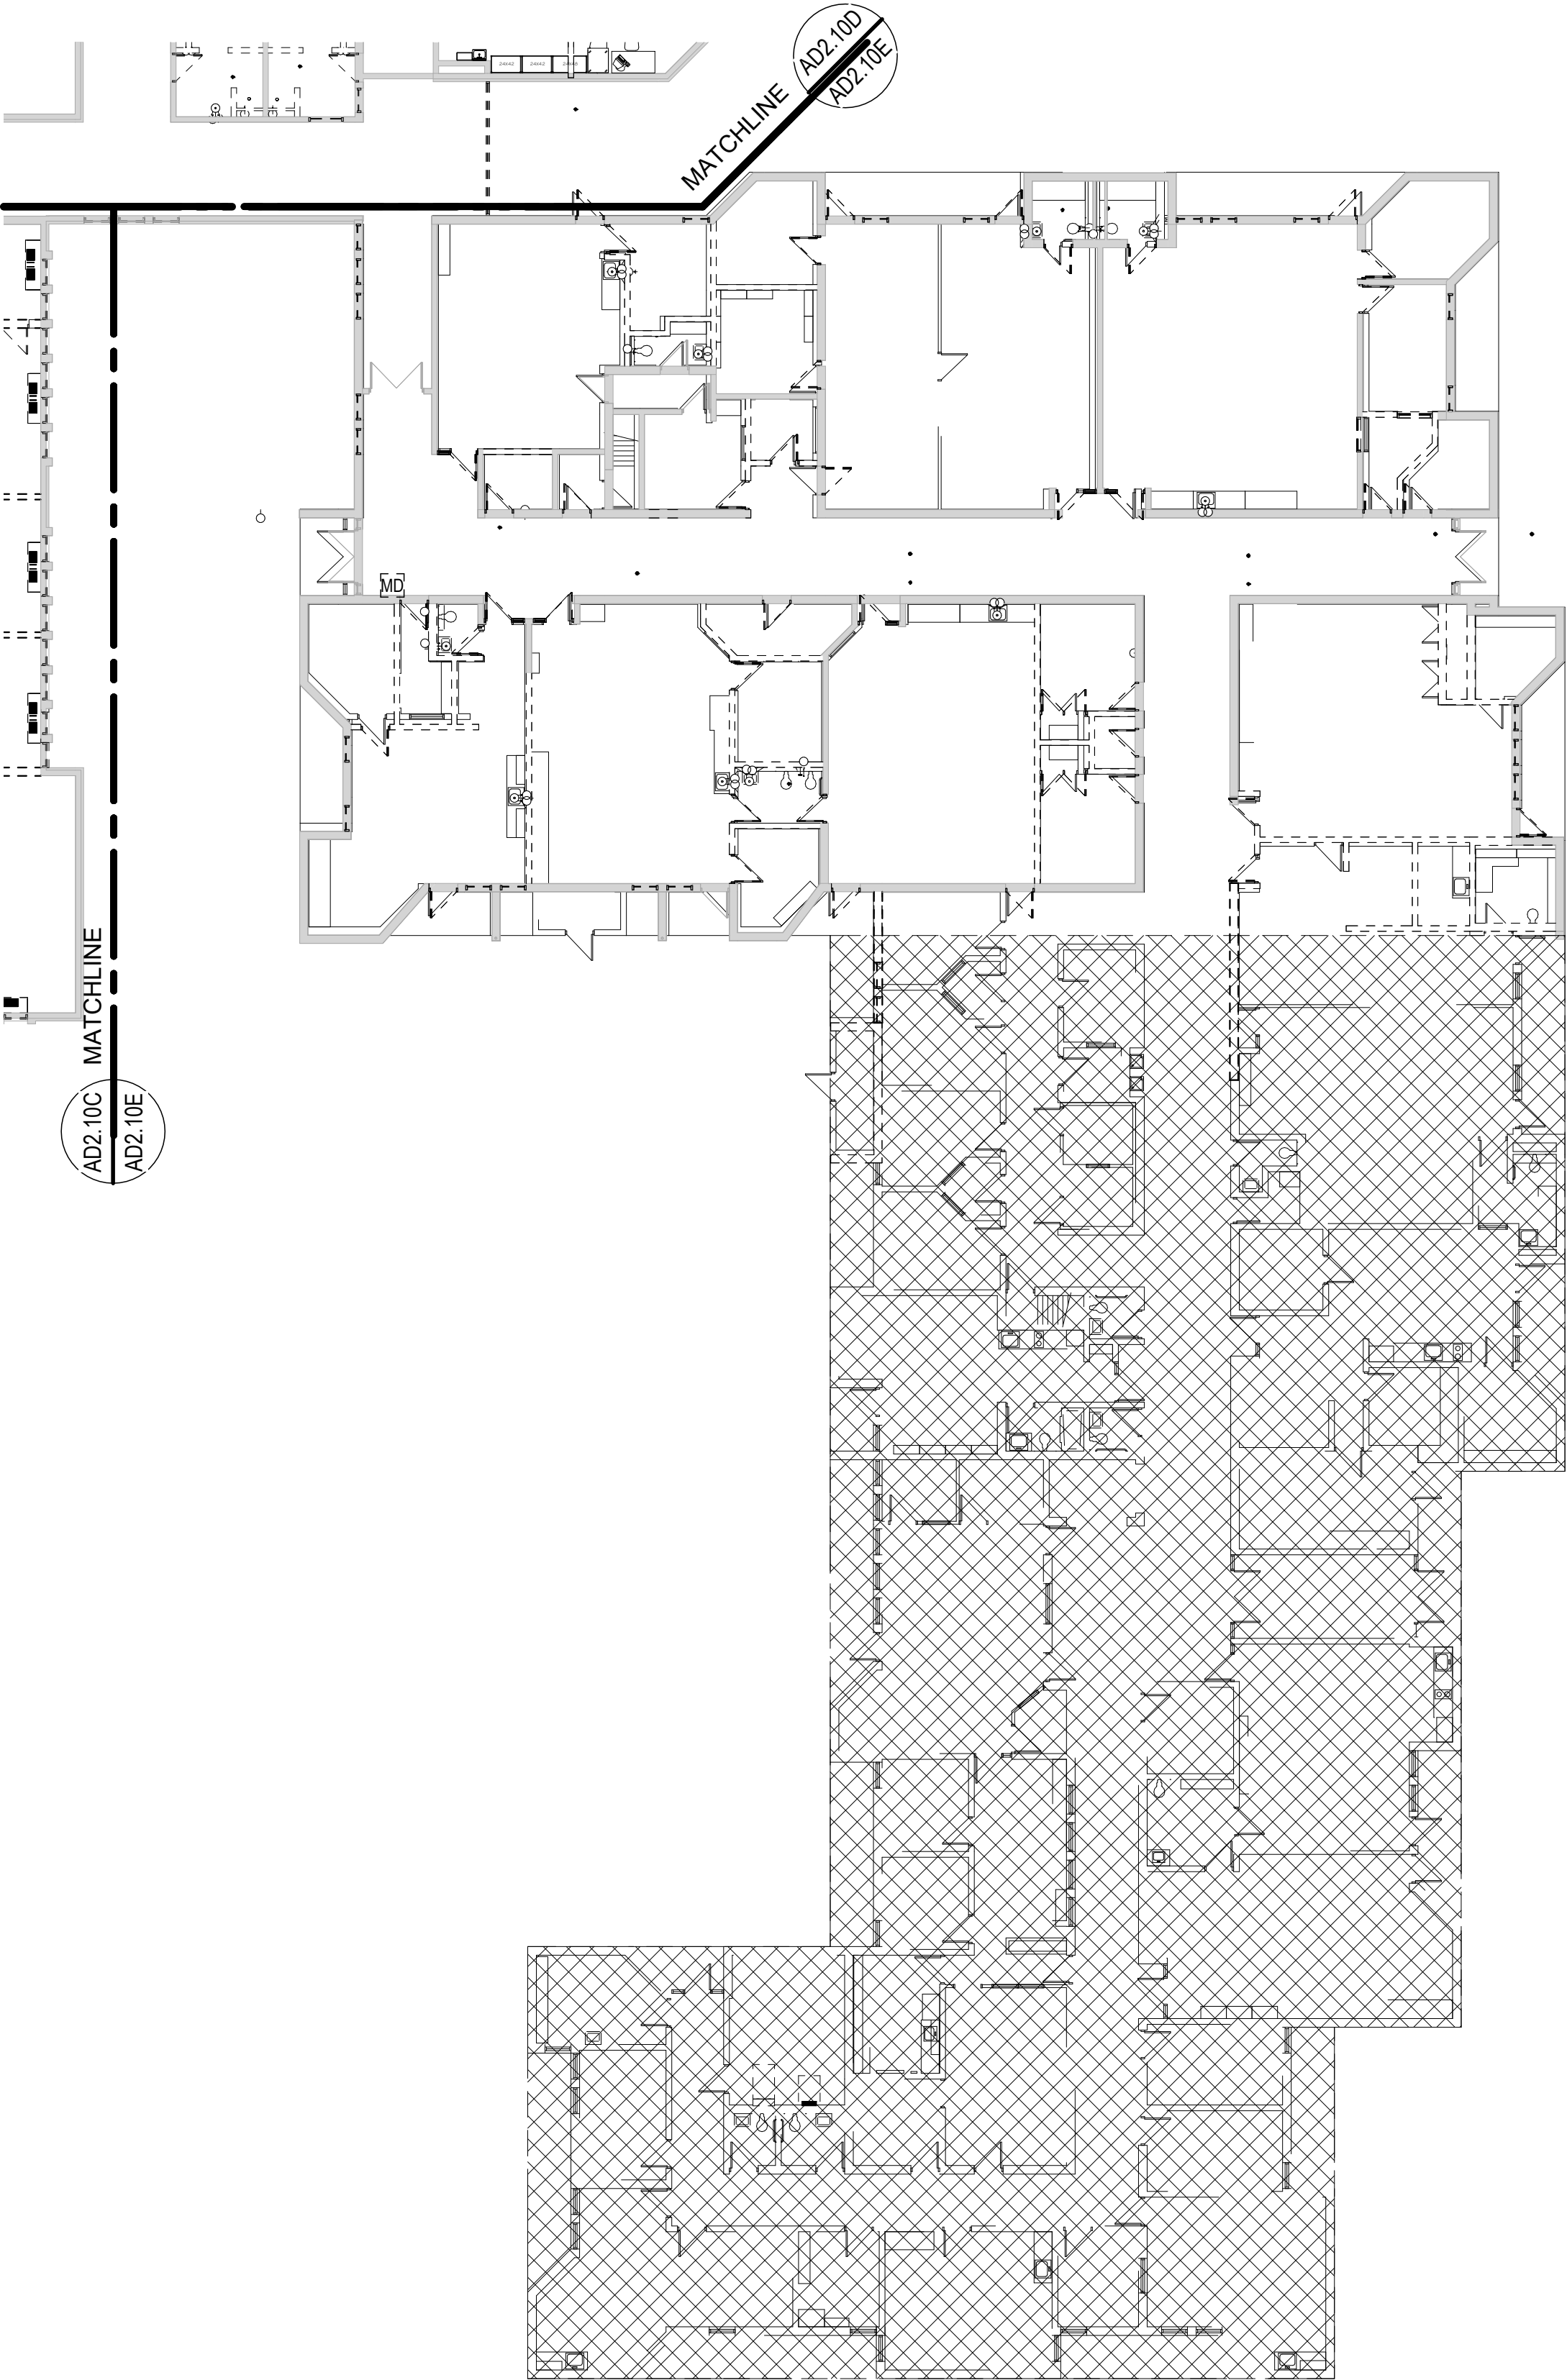
## AD2.10E

UNIT E FIRST FLOOR DEMOLITION PLAN -  
ADD. ALT. 1  
SCALE: 1/16" = 1'-0"

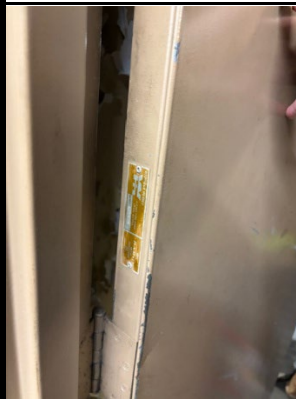
HA #: KES-7

This material **does contain asbestos.**

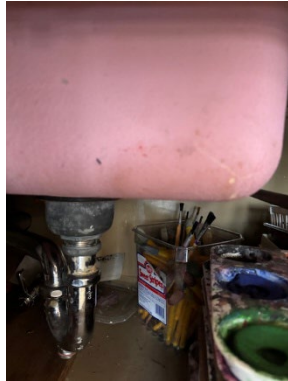
HA #: KES-9

This material **does contain asbestos**.

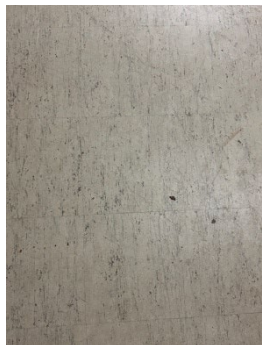
HA #: KES-11

These materials **contain asbestos**.

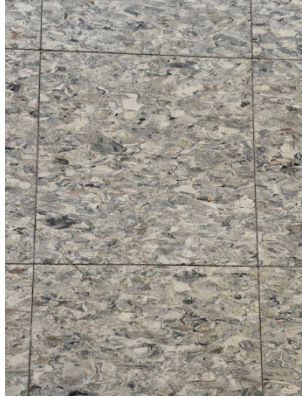
HA #: KES-15B

These materials **contain asbestos**.

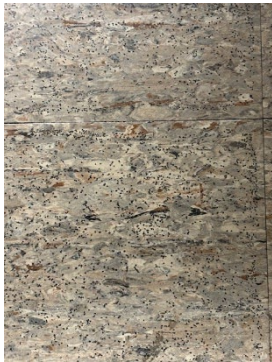
HA #: KES-16

These materials **contain asbestos**.

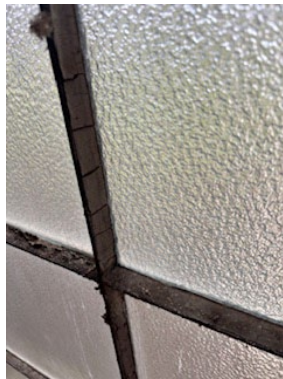
HA #: RSM-14

This material **contains asbestos**.

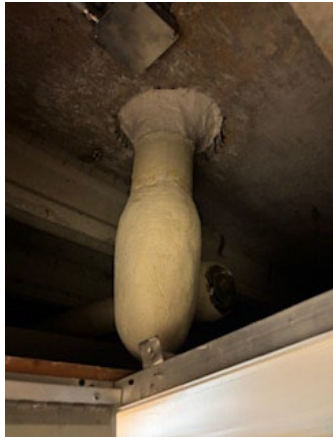
HA #: RSM-24

This material **contains asbestos**
